Citation: Binici, Hanifi, Binici, Fatih, Akcan, Mehmet, Yardim, Yavuz, Mustafaraj, Enea and Corradi, Marco (2020) Physical-Mechanical and Mineralogical Properties of Fired Bricks of the Archaeological Site of Harran, Turkey. *Heritage*, 3 (3). pp. 1018-1034. ISSN 2571-9408

# Physical–Mechanical and Mineralogical Properties of Fired Bricks of the Archaeological Site of Harran, Turkey

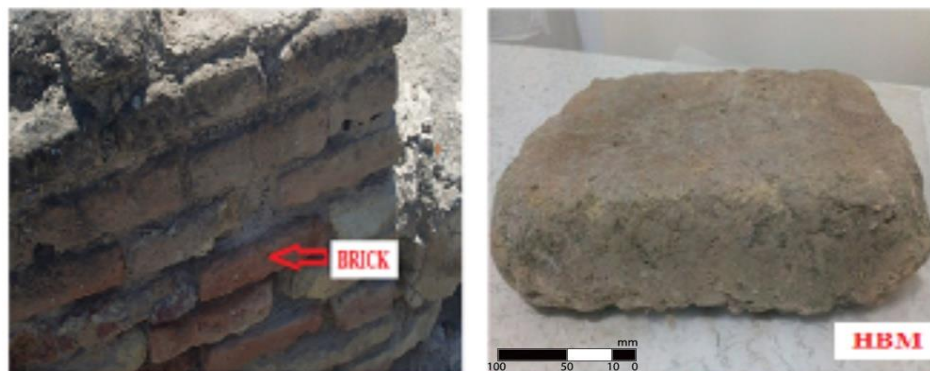
**Figure 4.** Brick sample taken from the burial mound (HBM).

Five brick samples were taken from different historical ruins of the city: the burial mound, the university, the city walls, the castle and the great mosque, from undisturbed parts of these buildings. While extracting the brick samples, special attention was paid not to spoil the unique structures of the bricks and photos of places from where the samples were taken, and photos of the taken brick samples were filed. The five selected buildings are shown in Figure 3. A detail of a wall of the burial mound is given in Figure 4.

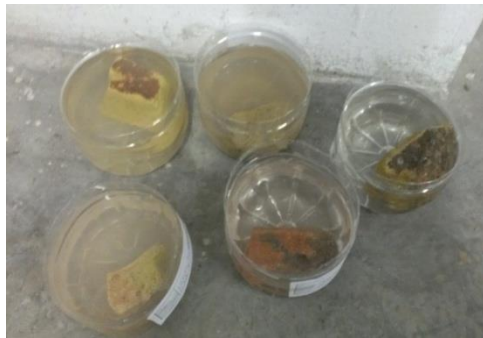
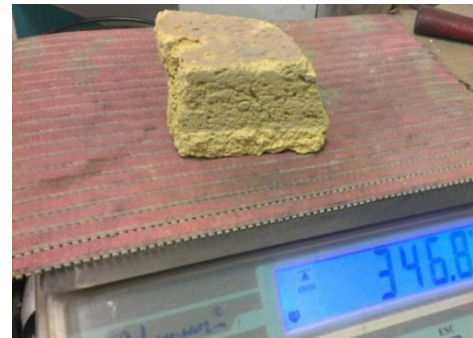
**Figure 6.** Water absorption tests.

Physical analyses allowed us to determine the water absorption rates by weight and by volume of the brick samples. Apart from the compressive strength, it is well-known that water absorption is an important property in brickwork masonry. This property can affect the quality of the brick itself and the bond strength between the brick and mortar in masonry structures and can result in reducing its strength properties. The authors [25] have previously conducted an experimental investigation to assess the physical, mineralogical, and chemical properties of the lime mortars used in the monuments of Harran. The test results carried out on the lime mortar and on the units (i.e., the bricks) could be critical for any future conservation measure and assessment of the structural safety of the masonry structures of the site of Harran: this could highly facilitate the estimation of the mechanical properties of the brickwork masonry. Water absorption rates by weight and by volume of the samples are given in Table 3. Figure 6 shows the tested specimen during soaking in water.

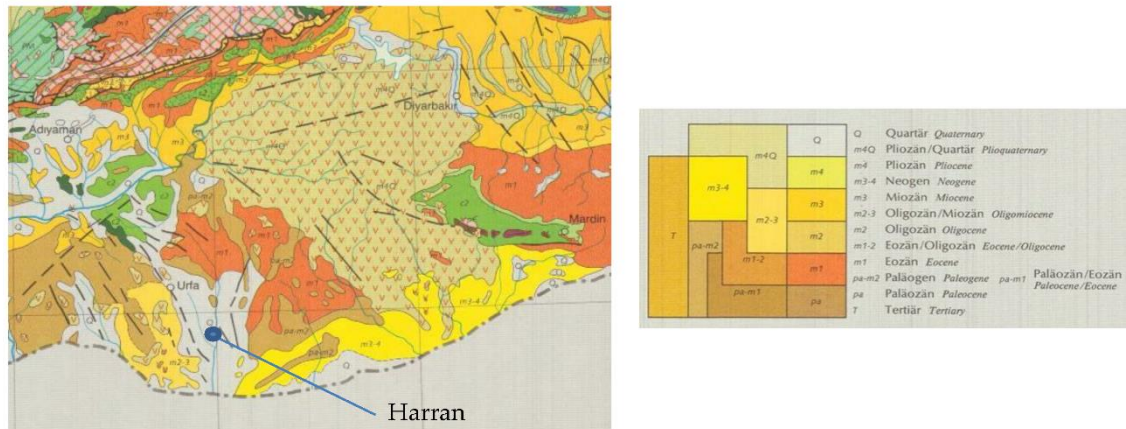
Figure 8. Geology of the area of Harran.

A large amount of information is available about the geology of the region of Harran. This is located in the basin of the Balikh river. This joins the Euphrates at the modern city of Raqqa. Figure 8 shows a geology map of the area of Harran: it can be noted that the rocks of the valley belong to the

Quaternary period, being the most recently laid geologic strata. Based on the low seismic risk of the area of Harran and its geology, with likely a low local amplification over a rocky soil, we can conclude that the seismic hazard for the site of Harran is relatively low. However, the site deserves a more in-depth analysis, also considering hazards from climate change (heavy rain falls, flooding, etc.) and their combined effects on the masonry monuments of Harran.

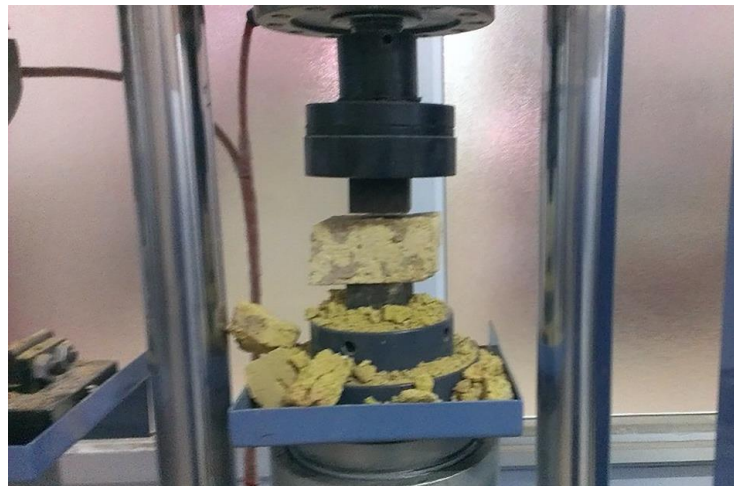
**Figure 10.** Compression test: the crumbling failure mode of brick specimens subjected to a compressive loading can be noted. This was the consequence of the low compressive strength and porosity.

The compressive strengths  $\sigma_{compr}$  of the brick samples vary between 6.69 and 7.95 MPa. The brick sample with the highest compressive strength value is the one taken from the burial mound. Figure 10 shows a brick specimen before being subjected to the compressive load: the underlying brick debris from previous tests clearly demonstrate that the samples' failure mode was due to crumbling/pulverization of the tile material. This is a well-known failure mechanism that is normal for low-strength, porous masonry materials [57].

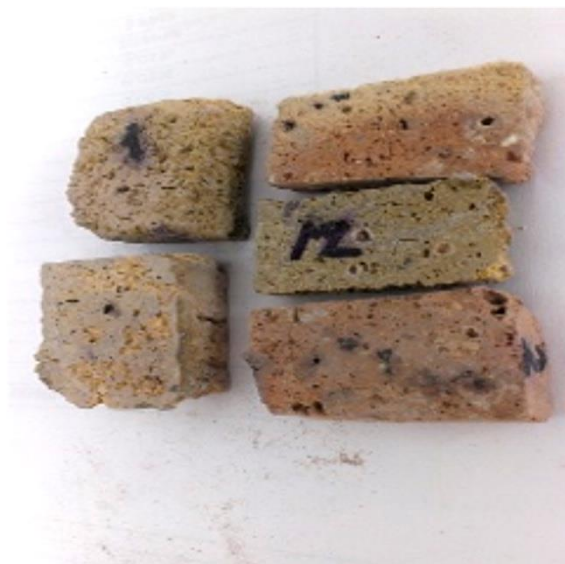
**Figure 11.** Detail of the brick cross-section.

The sample with the lowest compressive strength value is the one taken from the city walls. According to previous studies [58], it is possible to say that the compressive strength values of the brick samples are very similar and in a limited range (6.69–7.95 MPa). This could suggest that the Harran monuments, constructed in different periods of time, have been manufactured using a similar or non-time-varying technology, labor, resources, and environmental conditions. This could strengthen the hypothesis that local skills, construction materials, and methods were passed down from father to son for generations in family brick companies, also considering the frequent changing of rulers (from Parthians to Romans, from Byzantines to Arabs, and finally to the Mongols and Turkish). The thin-section images of the five brick samples taken from the historical structures are quite similar to each other (Figure 11).
